## ANALYSIS OF SPRUCE WOOD DEFORMATION DURING COMPRESSION TESTING

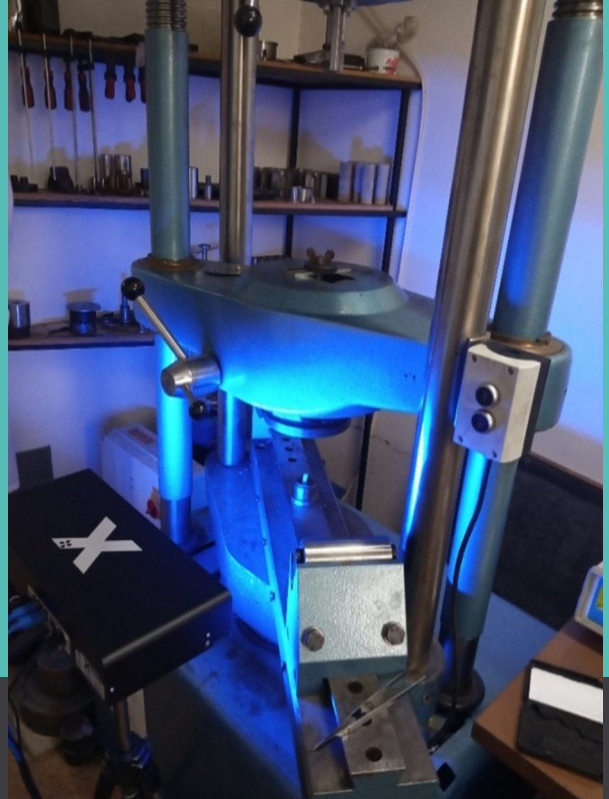
▼ 4105-3D Extensometer with Universal Testing machine

- 4105-3D optical extensometer
- Universal testing machine ZD-40
- Stochastic pattern kit
- Alpha DIC® modules: AX, DIC
- Measuring tools:
  - DIC Area
  - Line probe
  - Point probe

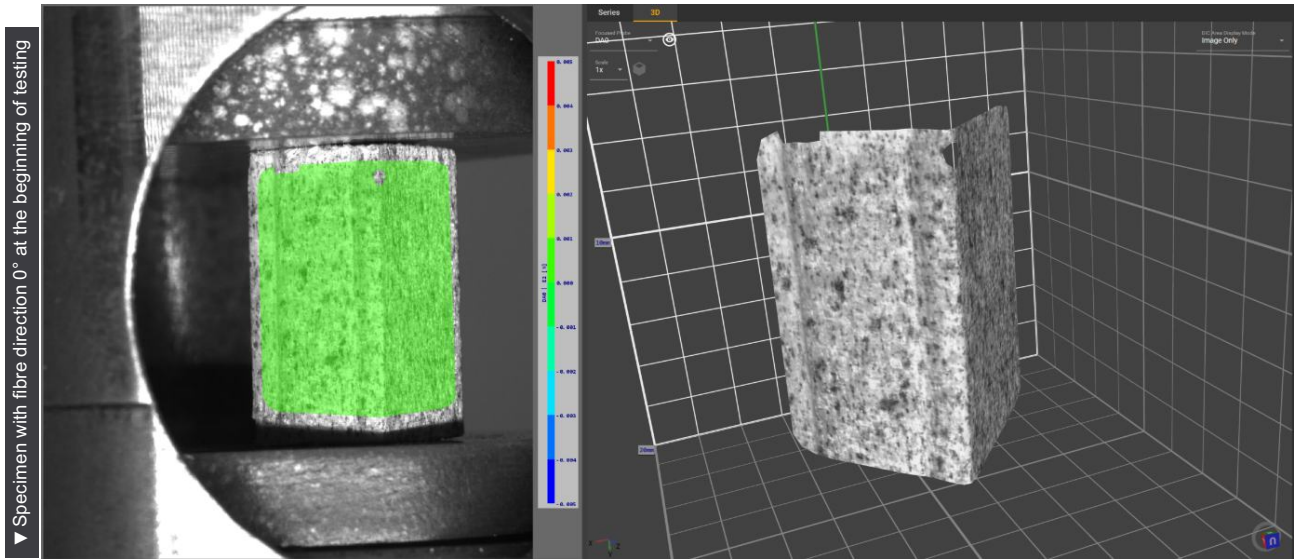
It was observed that wood exhibits anisotropic behaviour, deforming differently along various directions. To accurately capture local deformations, the evaluation region in the 3D video extensometer with post-processing software was configured so that two sides of the specimen are visible. This adjustment was necessary because small wood specimens tend to gradually chip or shear near the edges due to surface slippage along the compression tool, potentially generating unwanted deformation extremes.

▼ Specimen with fibre direction 0° at the beginning of testing

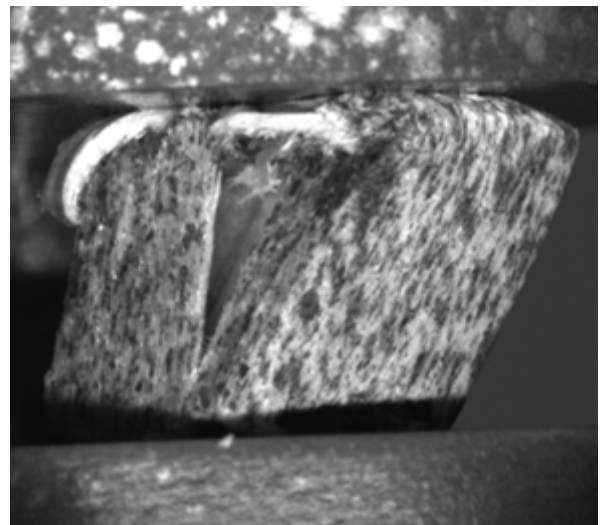
As testing progressed, localized splitting along the wood fibres was observed across all fibre orientations. In some instances, slight sliding occurred along these fracture lines. Despite these failures, the material retained partial internal cohesion and did not completely separate. This gradual failure was accompanied by a slow decline in deformation resistance, indicating that the structural integrity had been compromised. Beyond this point, the material's behavior became increasingly unpredictable.

▲ Splitting of wooden specimens

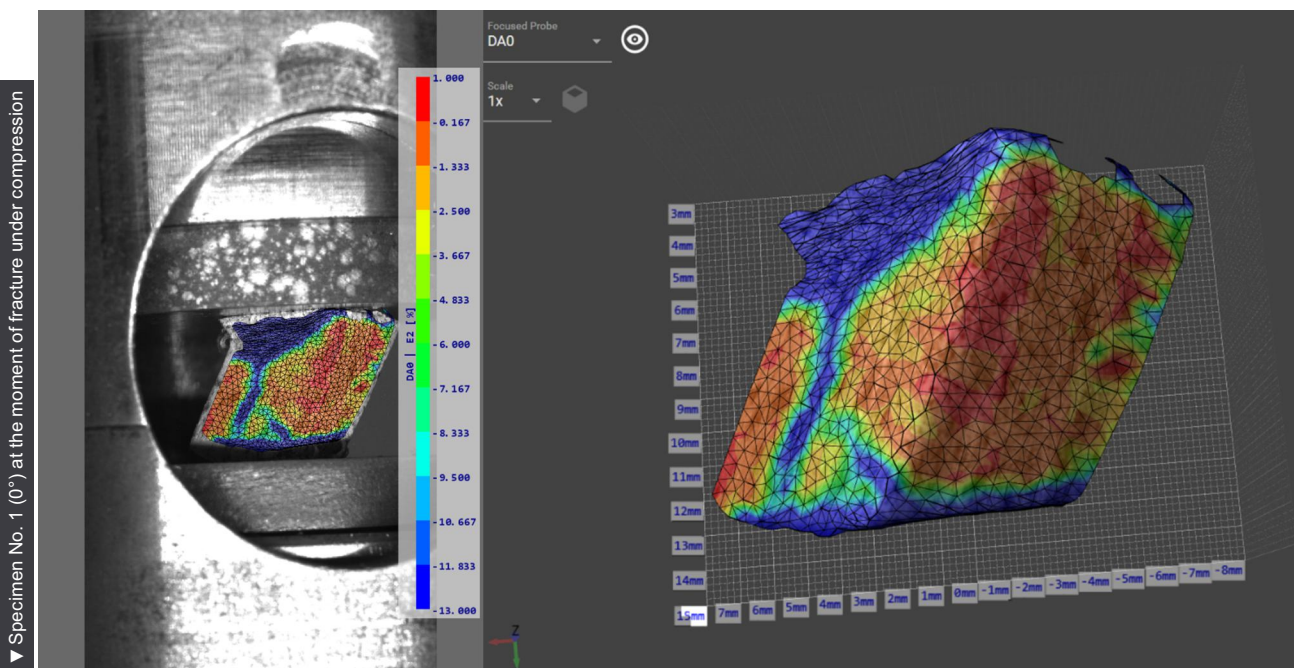
In the 0° direction, the wood sample initially showed a uniform distribution of compressive stress, increasing steadily within the elastic range up to a subtle yield point. Beyond this, the material entered a plastic phase, where resistance to deformation remained relatively stable. The end of the test was determined at the point where a definite fracture can be observed. Following image shows this moment for the specimen no.1.

▼ Specimen No. 1 (0°) at the moment of fracture under compression

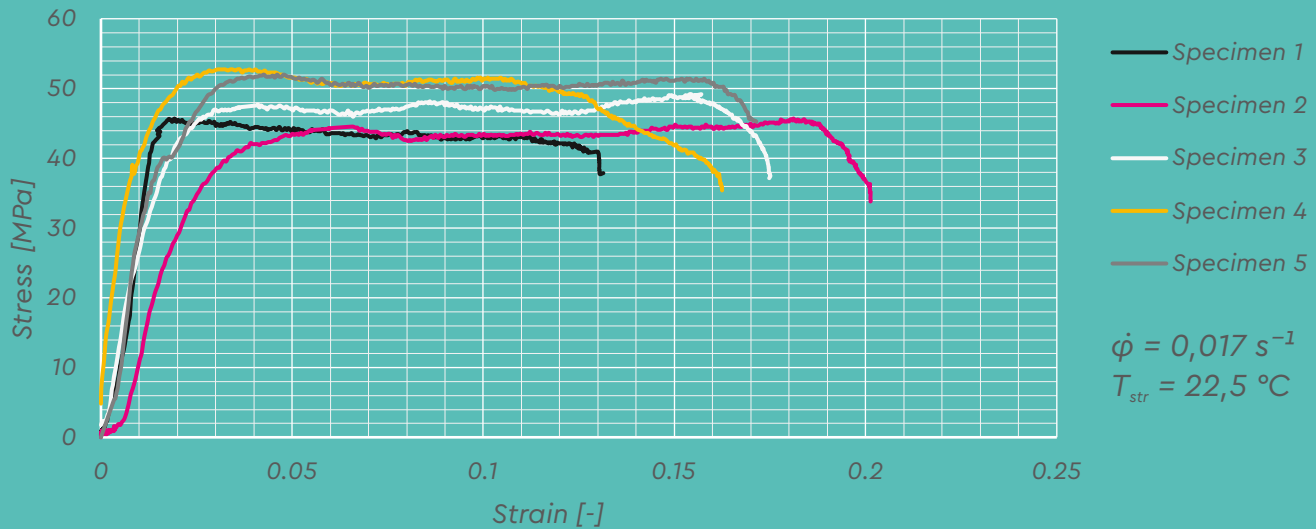
Following diagram shows the stress-strain dependencies that were measured. After yield stress is reached a long stable area of plastic deformation is observed upon which a sudden splitting occurs.

▲ Stress-strain diagram of specimens compressed with 0° fibre direction

For consistency all specimen direction were measured five times. Upon which a statistical analysis of the data needs to be performed. Evaluated parameters were Yield stress, Ultimate compression stress and modulus of elasticity. During the testing of a relatively stable behaviour occurs, but mechanical properties still vary in a significant way. With Yield stresses various up to 11%. The calculated parameters are shown in the following table:

Fibre direction 0°	Mean value	Standard deviation	Minimum	Maximum
Yield stress Rp0,2 [Mpa]	30,8	3,3	27,8	35,9
Ultimate compression stress Rm [Mpa]	49,2	3,2	45,7	52,8
Modulus of elasticity E [Mpa]	3191,1	872,1	2226,4	4369,9

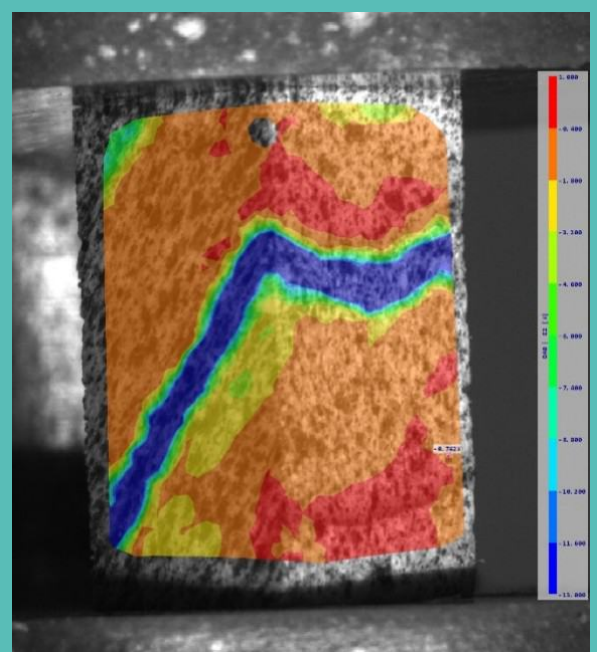
At an angle of 45°, fibre compression begins from the start of the test along one of the planes parallel to the grain. It can be assumed that this represents the compression of the softer (springwood) layer of the growth ring between two harder (summerwood) layers. A strong concentration of deformation soon appears along another plane, also parallel to the grain.

The specimen deforms through gradual sliding along this plane, resulting in the development of localized shear stress. The remaining surface of the sample is subjected to a uniform load.

A brittle fracture occurred along the shear plane. The sample split into two separate bodies, which slid freely along the fracture surface. The graph has a similar shape to that in the 0° direction, but with significantly lower values of maximum deformation resistance. Failure of the sample also occurred at seemingly random points within the plastic region.

▲ Strain map on 45° fibre direction specimens

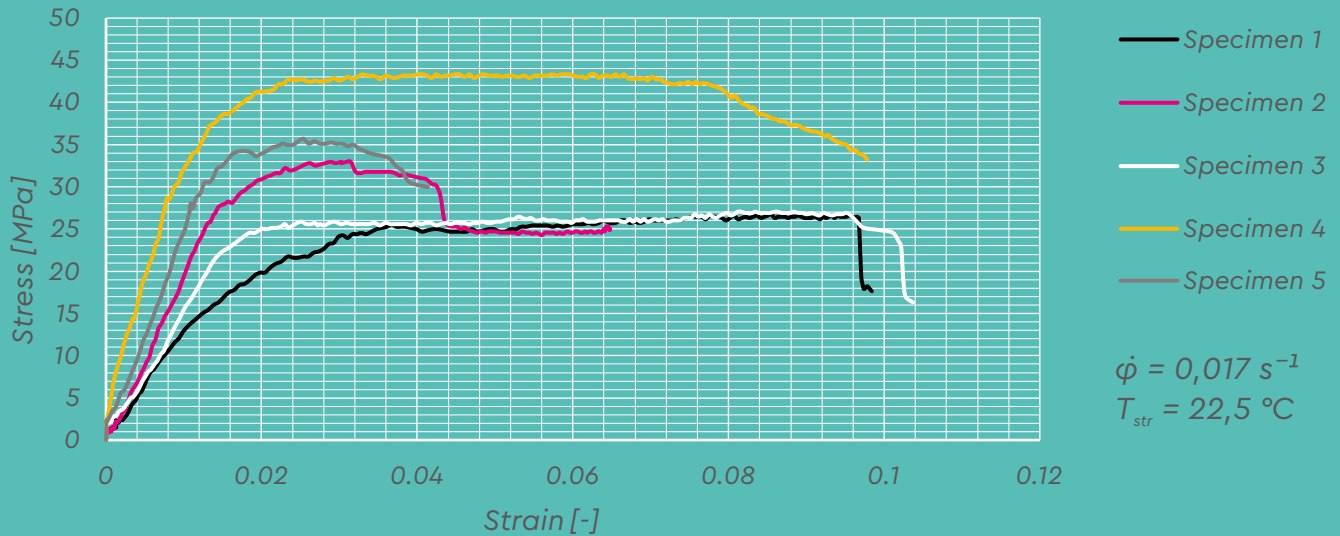
▲ Stress-strain diagram of specimens compressed with 45° fibre direction

Fibre direction 45°	Mean value	Standard deviation	Minimum	Maximum
Yield stress Rp0,2 [Mpa]	22	6,9	14,7	30,3
Ultimate compression stress Rm [Mpa]	33,2	6,9	26,7	43,4
Modulus of elasticity E [Mpa]	2071,8	713	1243,2	3008,1

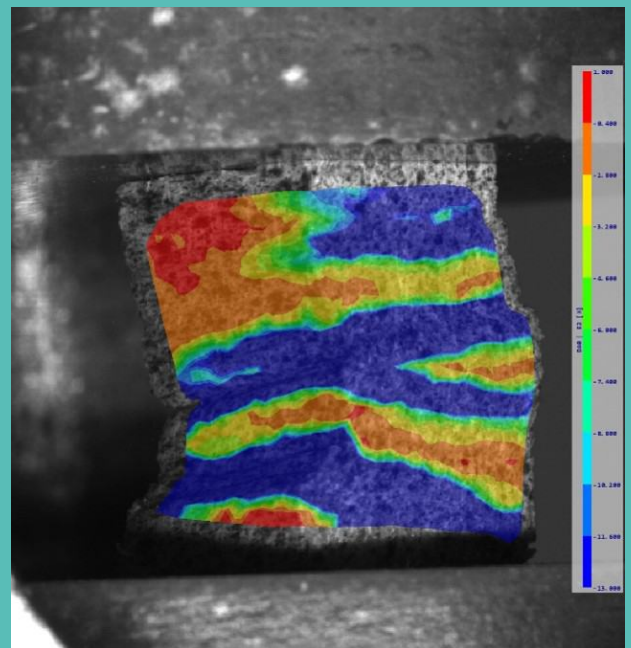
In the 90° direction, i.e., perpendicular to the grain, deformation concentration was again observed from the beginning of the test. In the sample shown in the image, fibres were significantly compressed along at least three planes across the specimen. As deformation progressed, it became evident that on one side, the wood compressed faster in these regions, leading to an inclined deformation of the entire sample. This tilting may have been caused by geometric imperfections in the specimen or by internal structural flaws. In the later stages of the test, waviness appeared on the side surfaces of the samples. Complete failure of the specimen did not occur under this loading direction, but cracks formed at the bulging areas of the wavy surface. In these locations, local stresses can be observed in the 3D visualization. In the 90° direction, the differences in behaviour between individual samples were smaller than in other directions. A linear relationship was observed in the elastic region up to a clearly defined yield point. Beyond that, the material deformed with slight, seemingly linear strain hardening. At the end of this region, the hardening began to increase sharply.

▲ Strain map on 90° fibre direction specimens

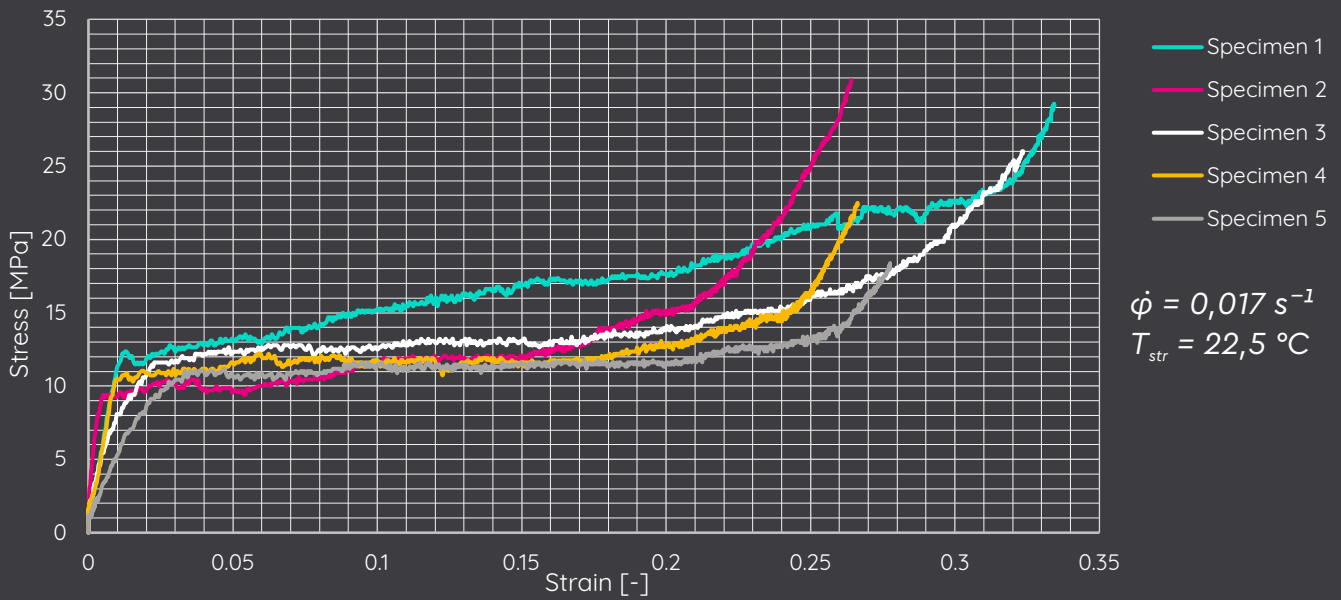
▲ Stress-strain diagram of specimens compressed with 90° fibre direction

Fibre direction 90°	Mean value	Standard deviation	Minimum	Maximum
Yield stress Rp0,2 [Mpa]	10,9	1,2	9,3	12,3
Ultimate compression stress Rm [Mpa]	15	3,8	11,8	21,5
Modulus of elasticity E [Mpa]	532,5	250,6	244,5	934,8
